Mount Morris Lake

Comprehensive Lake Management Plan

June 2006

Created by: Tim Hoyman
Onterra, LLC
De Pere, WI

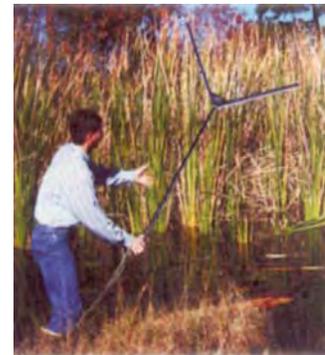
Manual removal methods include hand-pulling, raking, and hand-cutting. Hand-pulling involves the manual removal of whole plants, including roots, from the area of concern and disposing them out of the waterbody. Raking entails the removal of partial and whole plants from the lake by dragging a rake with a rope tied to it through plant beds. Specially designed rakes are available from commercial sources or an asphalt rake can be used. Hand-cutting differs from the other two manual methods because the entire plant is not removed, rather the plants are cut similar to mowing a lawn; however Wisconsin law states that all plant fragments must be removed. One manual cutting technique involves throwing a specialized “V” shaped cutter into the plant bed and retrieving it with a rope. The raking method entails the use of a two-sided straight blade on a telescoping pole that is swiped back and forth at the base of the undesired plants.

In addition to the hand-cutting methods described above, powered cutters are now available for mounting on boats. Some are mounted in a similar fashion to electric trolling motors and offer a 4-foot cutting width, while larger models require complicated mounting procedures, but offer an 8-foot cutting width.

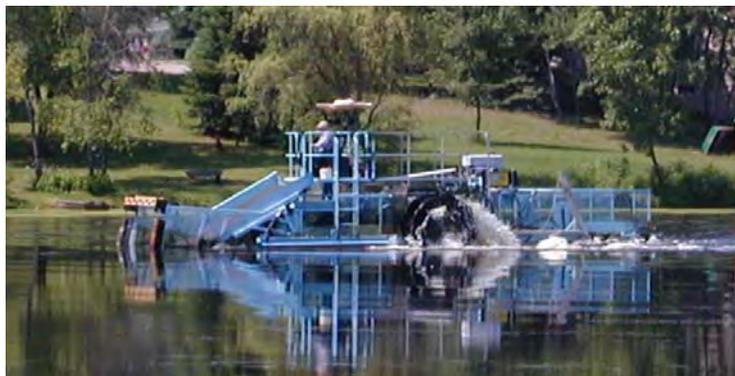
Aquatic plant harvesting is frequently used in Wisconsin and involves the cutting and removal of plants much like mowing and bagging a lawn. Harvesters are produced in many sizes that can cut to depths ranging from 3 to 6 feet with cutting widths of 4 to 10 feet. Plant harvesting speeds vary with the size of the harvester, density and types of plants, and the distance to the off-loading area. Equipment requirements do not end with the harvester. In addition to the harvester, a shore-conveyor would be required to transfer plant material from the harvester to a dump truck for transport to a landfill or compost site. Furthermore, if off-loading sites are limited and/or the lake is large, a transport barge may be needed to move the harvested plants from the harvester to the shore in order to cut back on the time that the harvester spends traveling to the shore conveyor.

Equipment costs vary with the size and features of the harvester, but in general, standard harvesters range between \$45,000 and \$100,000. Larger harvesters or stainless steel models may cost as much as \$200,000. Shore conveyors cost approximately \$20,000 and trailers range from \$7,000 to \$20,000. Storage, maintenance, insurance, and operator salaries vary greatly.
